VOLT HOME INSPECTIONS LLC

SAMPLE HOME INSPECTION

123 Someplace
Somewhere, IL 62293

NOVEMBER 15, 2022

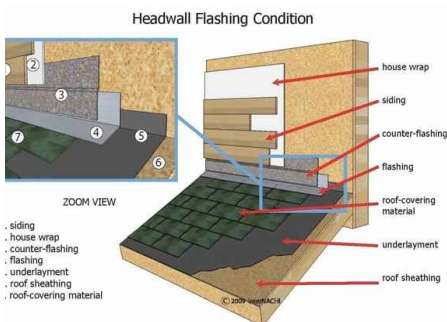
Flashing Details

I looked for flashing where the roof covering meets a wall or siding material. There should be step and counter flashing installed in these locations. This is not an exhaustive inspection of all flashing areas.

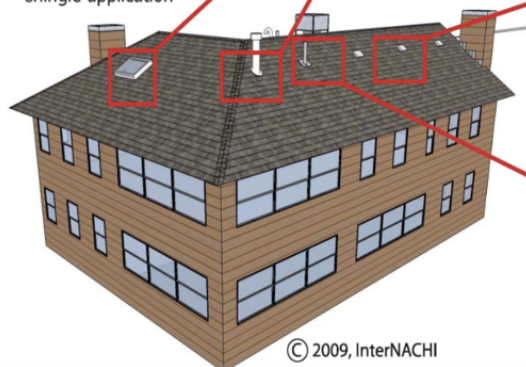
Plumbing Vent Pipes: Plumbing Vent Pipes Inspected

plumbing vent flashing and shingle application

I looked at DWV (drain, waste and vent) pipes that pass through the roof covering. There should be watertight flashing (often black rubber material) installed around the vent pipes. These plumbing vent pipes should extend far enough above the roof surface.

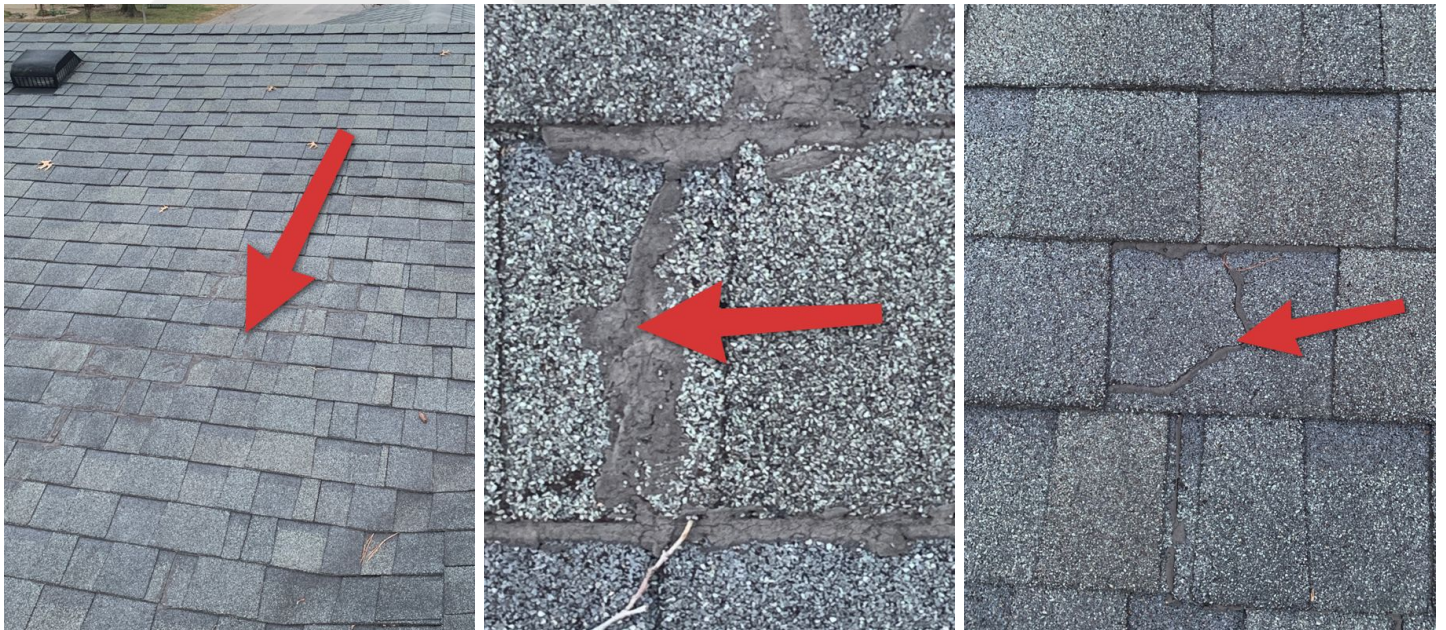
Major Defect**CRACKED ROOF-COVERING MATERIAL**

I observed cracked and damaged shingles. Prone to leaking. Correction and further evaluation by a professional roofer is recommended.

Contact a qualified roofing professional.

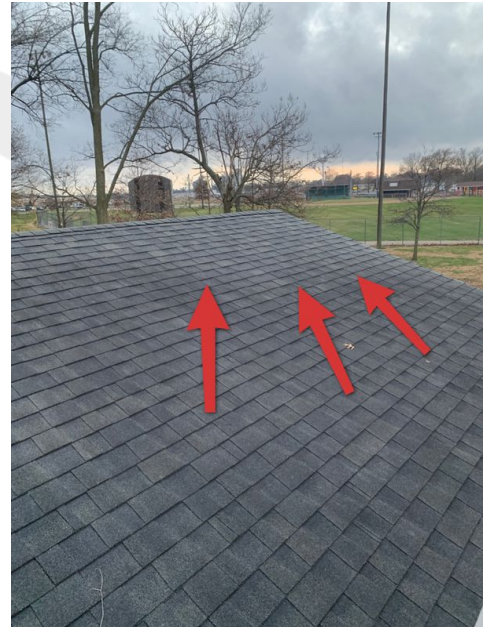
2.1.2 Roof Covering

Minor Defect**DISCOLORATION STAIN FROM ALGAE**

I observed indications of staining and discoloration on the roof-covering materials. This condition seemed to be caused from algae.

Algae attaches itself to the shingle by secreting a substance that bonds it tightly to the surface. Growth can be difficult to remove without damaging the roof. The best method is prevention. Algae stains can sometimes be lightened in color by using special cleaners.

Power-washing and heavy scrubbing may loosen or dislodge granules. Chemicals used for cleaning shingles may damage landscaping. Also, the cleaning process makes the roof wet and slippery, so such work should be performed by a qualified professional.

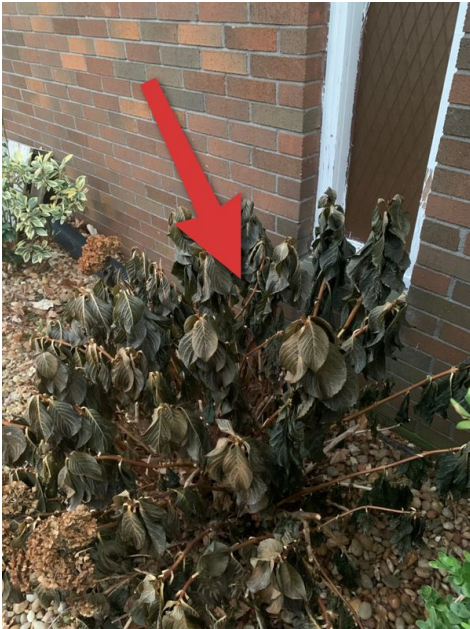
I observed dense vegetation around the house in areas. This condition limited and restricted my visual inspection. Dense vegetation and landscaping up against or near the house foundation and exterior walls may be prone to water penetration and insect infestation.

Trimming, pruning and some landscaping is recommended.

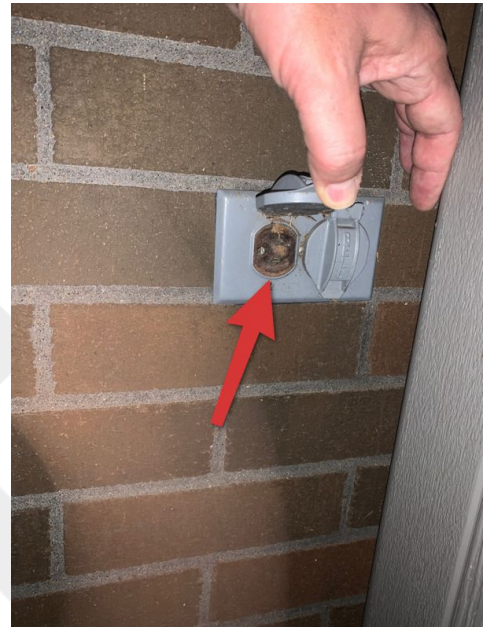
3.5.1 GFCIs & Electrical

MISSING GFCI

I observed indications that a GFCI is missing in an area that is required to keep people safe.

Contact a qualified electrical contractor.

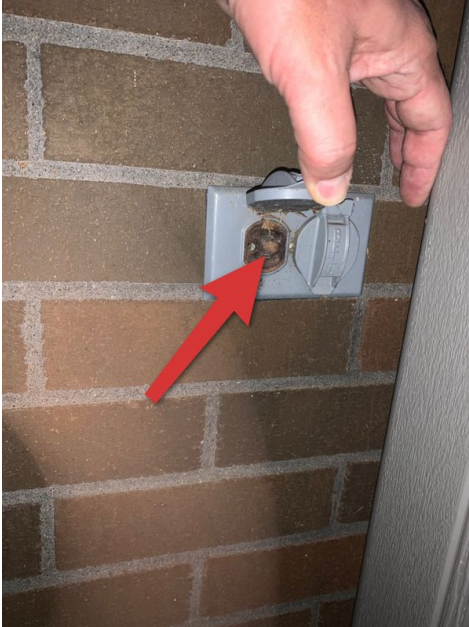
3.5.2 GFCIs & Electrical

ELECTRICAL DEFECT

I observed indications of an electrical defect at the exterior.

Contact a qualified electrical contractor.

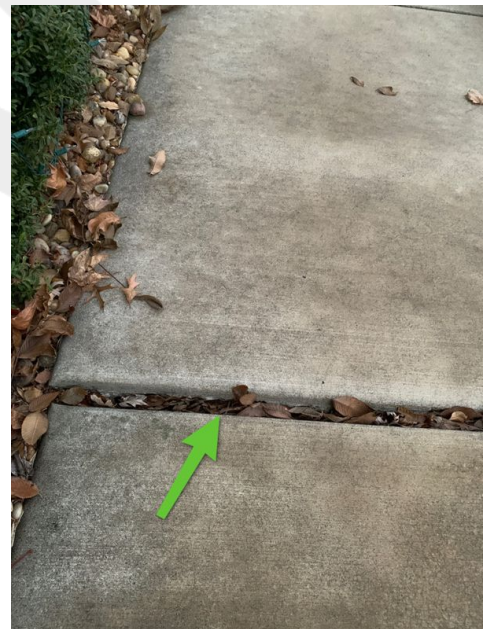
3.6.1 Walkways & Driveways

MAJOR CRACKING AT WALKWAY

I observed major cracking at the walkway. While a large crack is observed it does not appear to be a trip hazard.

Recommend monitoring.

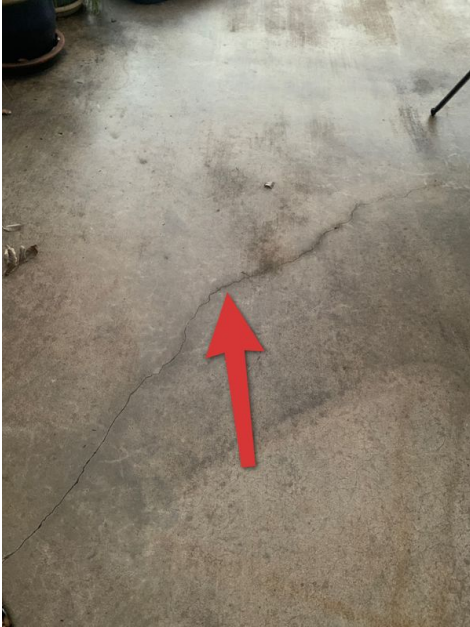
3.6.2 Walkways & Driveways

MINOR CRACKING AT WALKWAY

I observed minor cracking and no major damage at the northwest patio.

Monitoring is recommended.

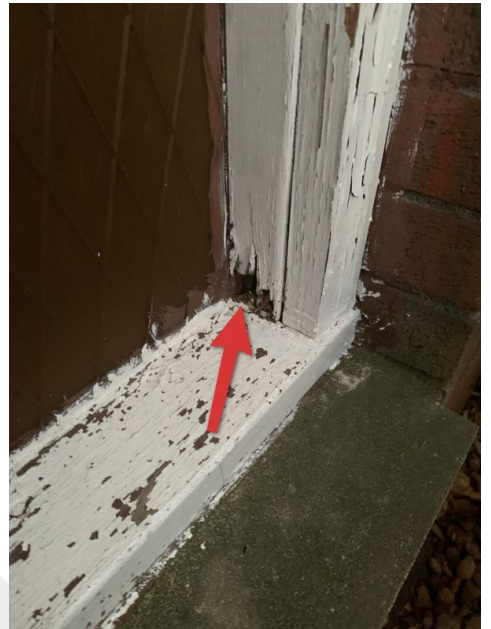
3.10.1 Windows

WOOD ROT AT WINDOW

I observed indications of wood rot at the window.
Correction and further evaluation is recommended.

Contact a qualified handyman.

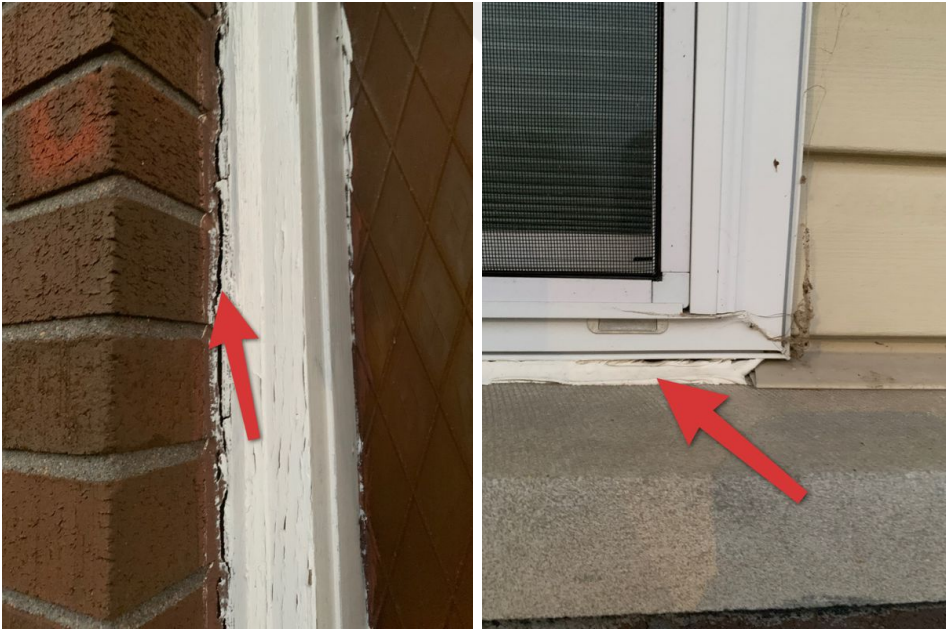
3.10.2 Windows

CAULKING DETERIORATED

I observed indications of deteriorated caulking at the window. Compromised caulking can lead to water and pest intrusion.

Correction and further evaluation are recommended.

Contact a handyman or DIY project

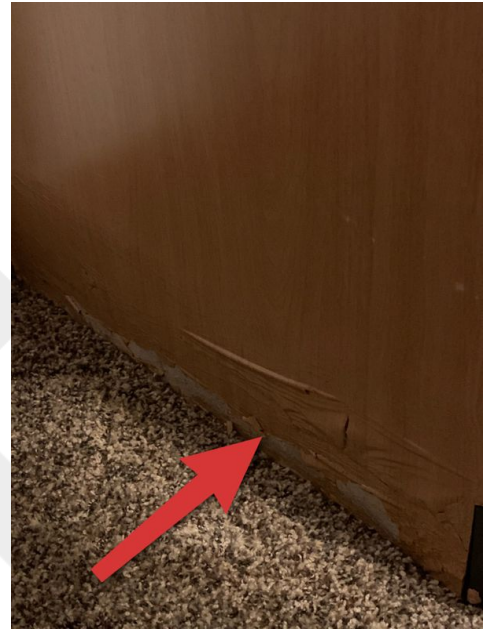
PRIOR WATER PENETRATION OBSERVED

I observed indications that sometime in the past, there was water penetration or intrusion into the house.

Correction and further evaluation is recommended. The current homeowner may have helpful knowledge on weather this was already addressed.

Recommend monitoring.

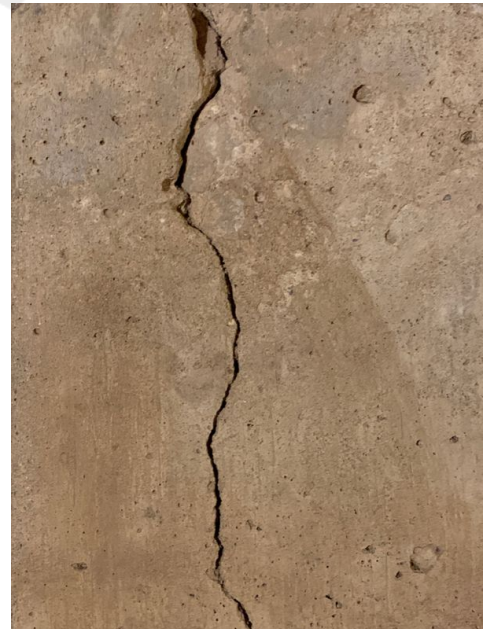
4.1.2 Basement

FOUNDATION CRACK - MINOR

I observed indications of a crack at the foundation. The crack is hairline with no major displacement or movement.

Recommend monitoring.

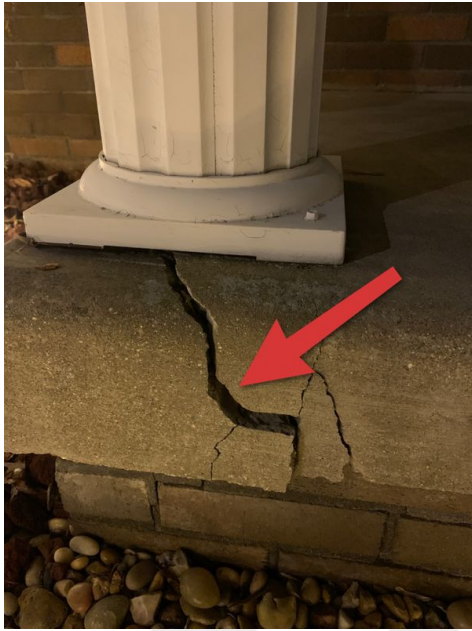
4.1.3 Basement

FOUNDATION CRACK - MAJOR

I observed a major crack at the south end of the porch foundation .

I am not a structural engineer. I recommend a structural engineer further evaluate and make recommendations related to this observation.

Contact a qualified concrete contractor.

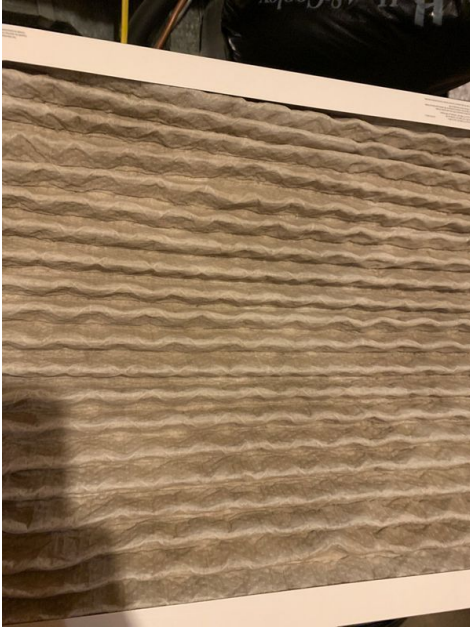
I observed a dirty air filter at the furnace filter.

Recommended DIY Project

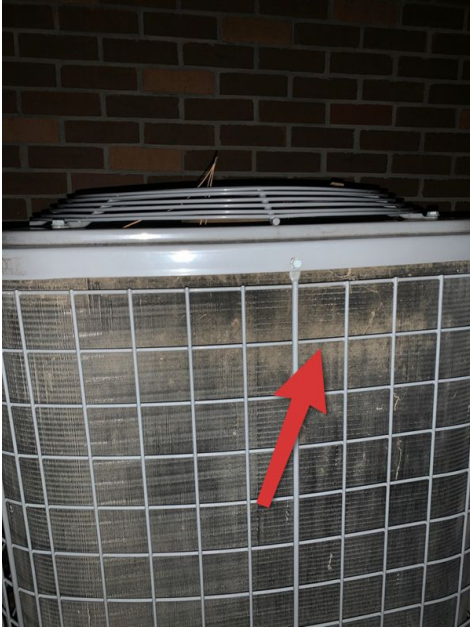
I observed that the air flow to the air conditioner unit was restricted because of dirt and debris. This may result in inefficient operation.

Contact a qualified HVAC professional.

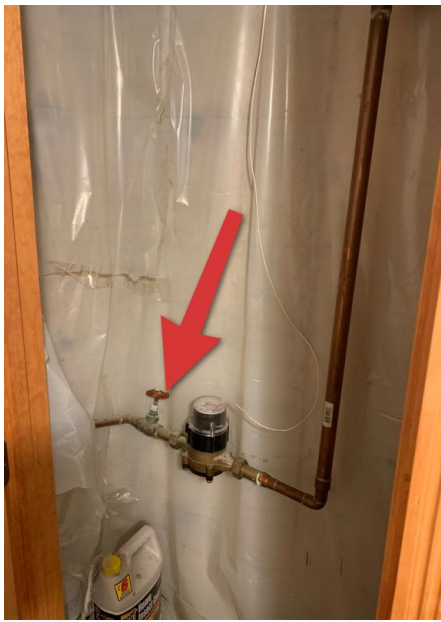
Basement

Southeast corner of the basement in a closet.

Southeast

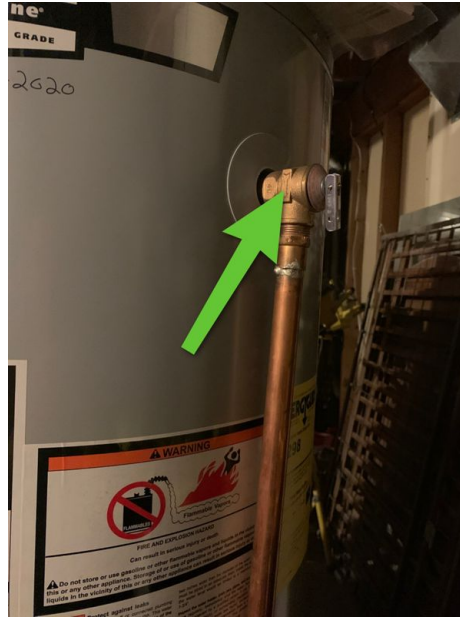
Hot Water Source: Inspected TPR Valve

I inspected the temperature and pressure relief valve.

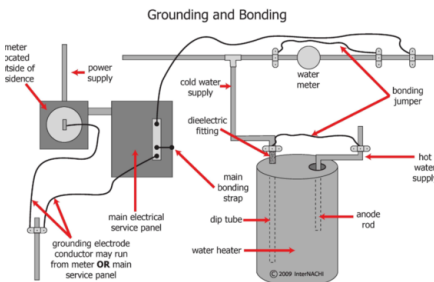
Service Grounding & Bonding: Inspected the Service Grounding & Bonding

I inspected the electrical service grounding and bonding.

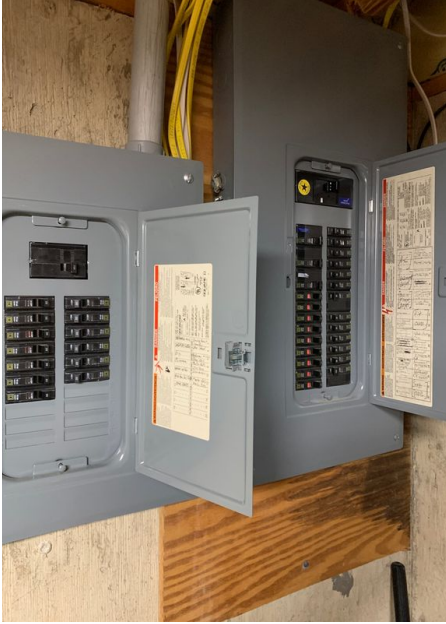
Panelboards & Breakers: Inspected Subpanel & Breakers

I inspected the electrical subpanel and over-current protection devices (circuit breakers and fuses).
